Manhole Inspection Summary

Manhole # S23Y__008MH

Location Address: **2201 Langley St.**

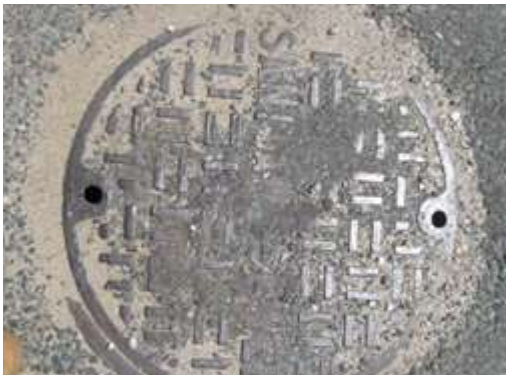
Misc

cover

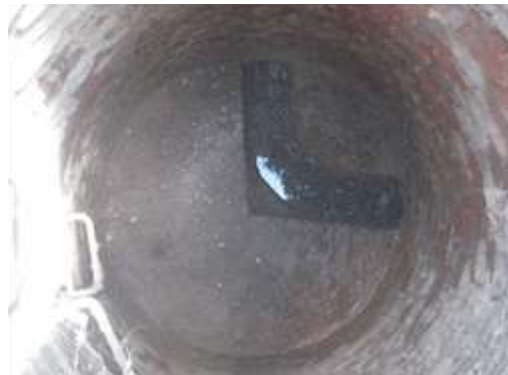
Defect 1

corroded steps

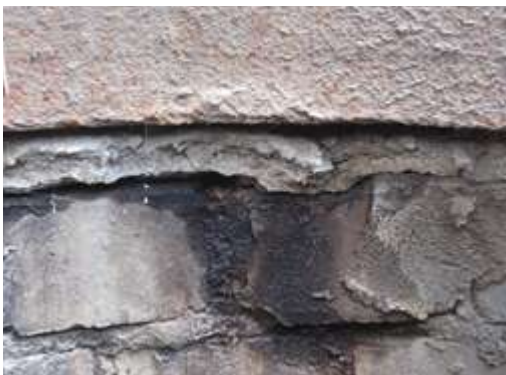
Defect 3

Condition: ☐ Sound ☐ Cracked ☐ Root Intrusion ☒ **Loose Brick** ☒ **Deteriorated**

Infiltration: ☐ None ☐ Joint ☐ Cracks ☒ **Mortar** ☐ Roots ☐ Wall

chimney loose bricks and deteriorated,
chimney infiltration at mortar

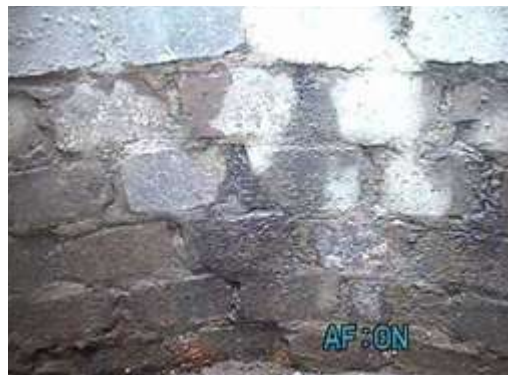
Defect 4

Infiltration: ☐ None ☐ Joint ☐ Cracks ☐ Mortar ☐ Roots ☒ **Wall**

barrel infiltration at wall

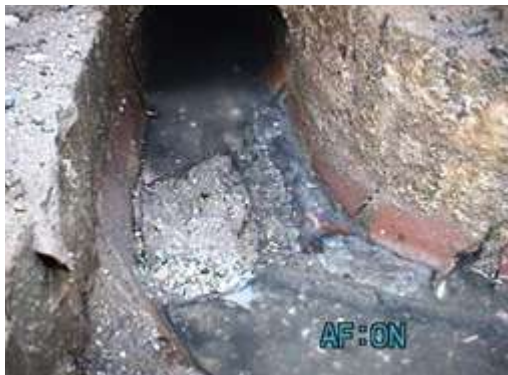
Defect 2

Condition: ☐ Sound ☐ Cracked ☐ Root Intrusion ☐ Deteriorated ☐ Leaks ☒ **Debris**

channel debris

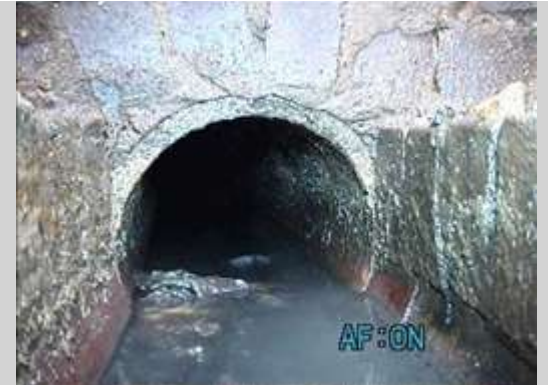
12 O'Clock Outflow

Pipe Height: **8.4** (in.) Rod and Bar (Angled)
Pipe Material: **Clay** ☐ Pipe Lined
Invert Depth: **7.77** (ft.) Flow Characteristics: **None**
Deposits: ☒ None ☐ Mud ☐ Sludge ☐ Debris ☐ Grease
Silt Depth: **0** (in.) Deposits Extent:
Infiltration: **None** Pipe Seal Cond: **Sound**

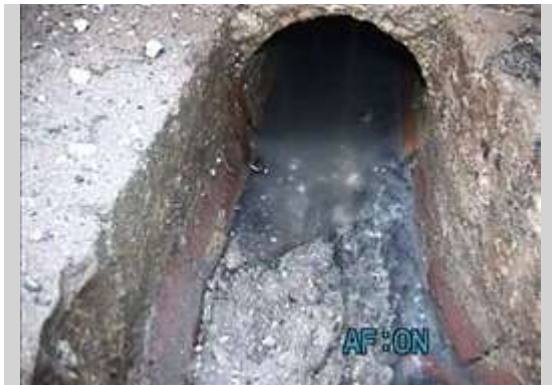
3 O'Clock Inflow

Pipe Height: **8.4** (in.) Rod and Bar (Angled)
Pipe Material: **Clay** ☐ Pipe Lined
Invert Depth: **7.70** (ft.) Flow Characteristics: **None**
Deposits: ☒ None ☐ Mud ☐ Sludge ☐ Debris ☐ Grease
Silt Depth: **0** (in.) Deposits Extent:
Infiltration: **None** Pipe Seal Cond: **Sound**
